Hedquarters and Offices- Production Plant

REV. 2 del 10/08/2015

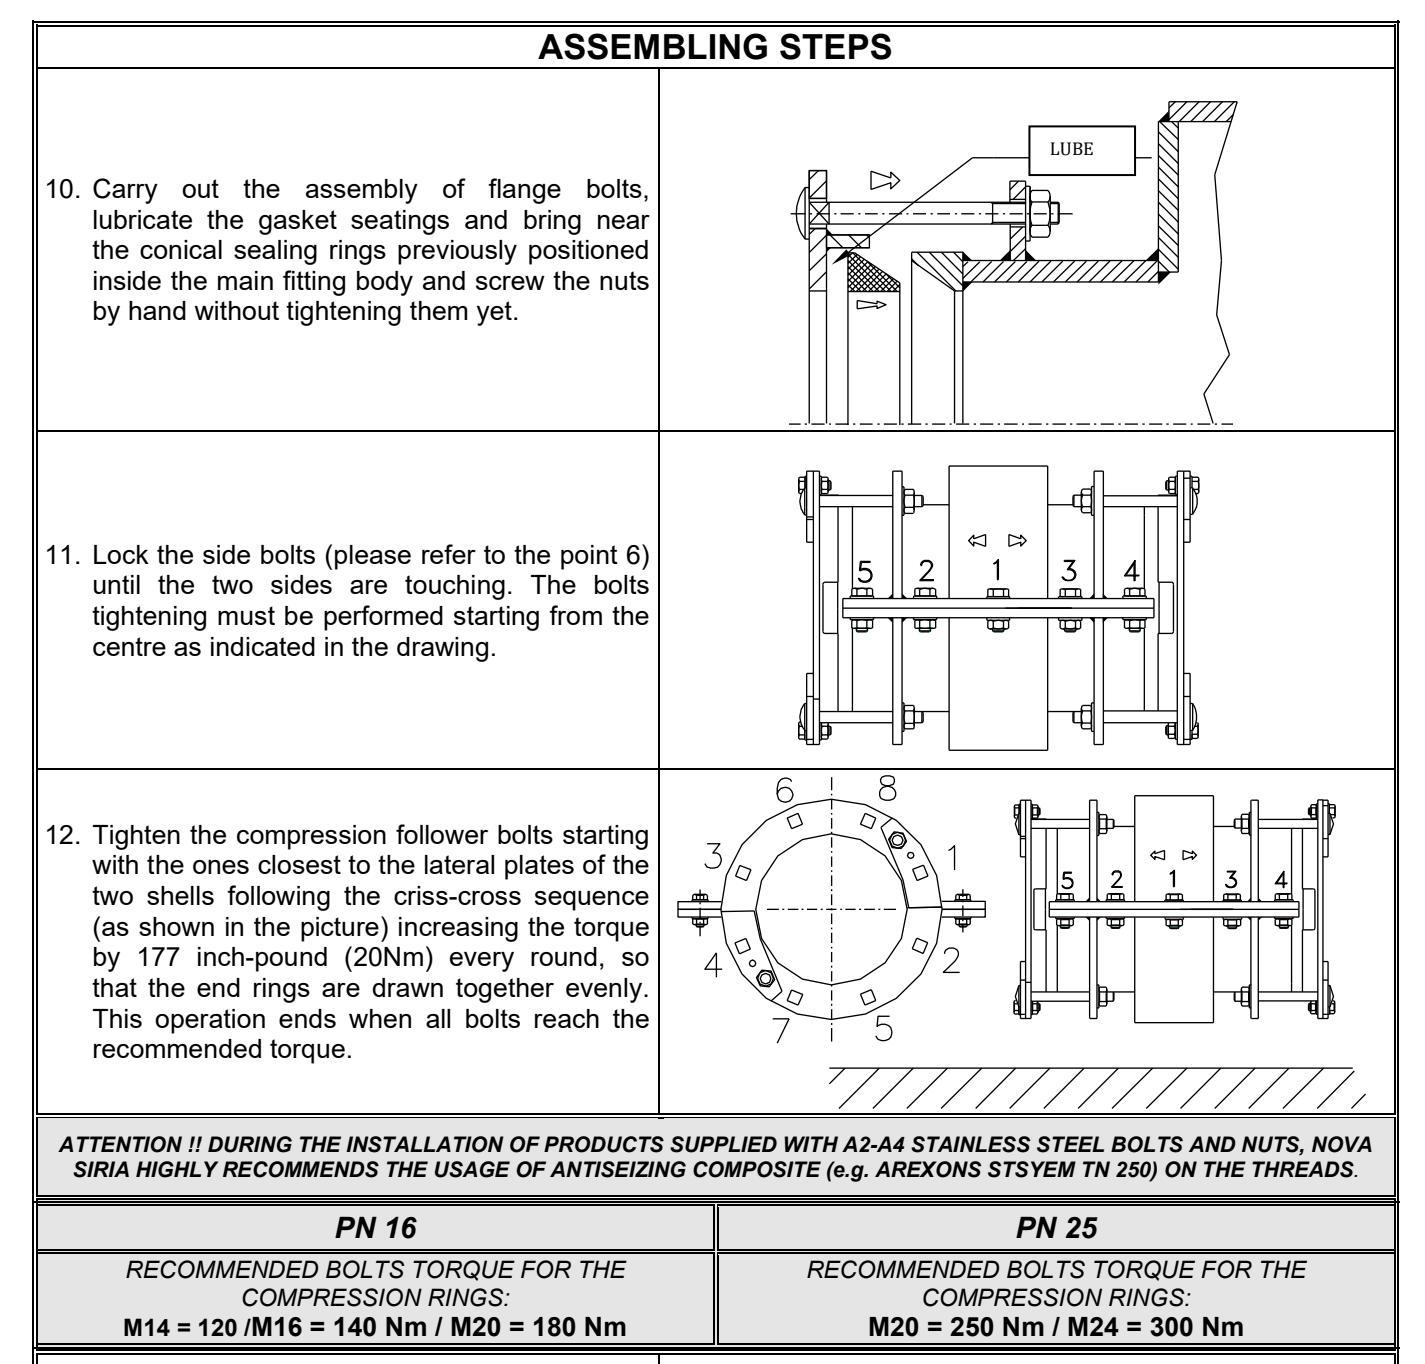
13. Screw the lower discharge plug back to the place and fill, using water coming out the leakage or pouring water from the outside, the Duofit cavity reducing the presence of air at the minimum possible and finally close the top plug.

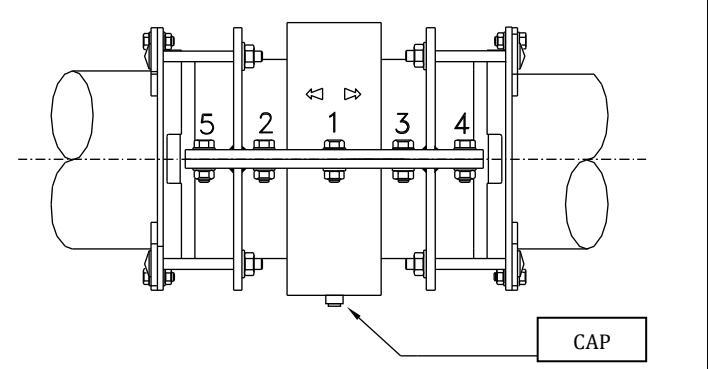
"MULTISIZE" - "LARGESIZE" COUPLINGS DO NOT PREVENT PIPE AXIAL MOVEMENT
